ARCHAEOLOGICAL
SERVICES

-----LETTER REPORT-----

RE: Results of Archaeological Monitoring for the Lindsey Lake Fuel Spill Cleanup, Hood River County, Oregon.

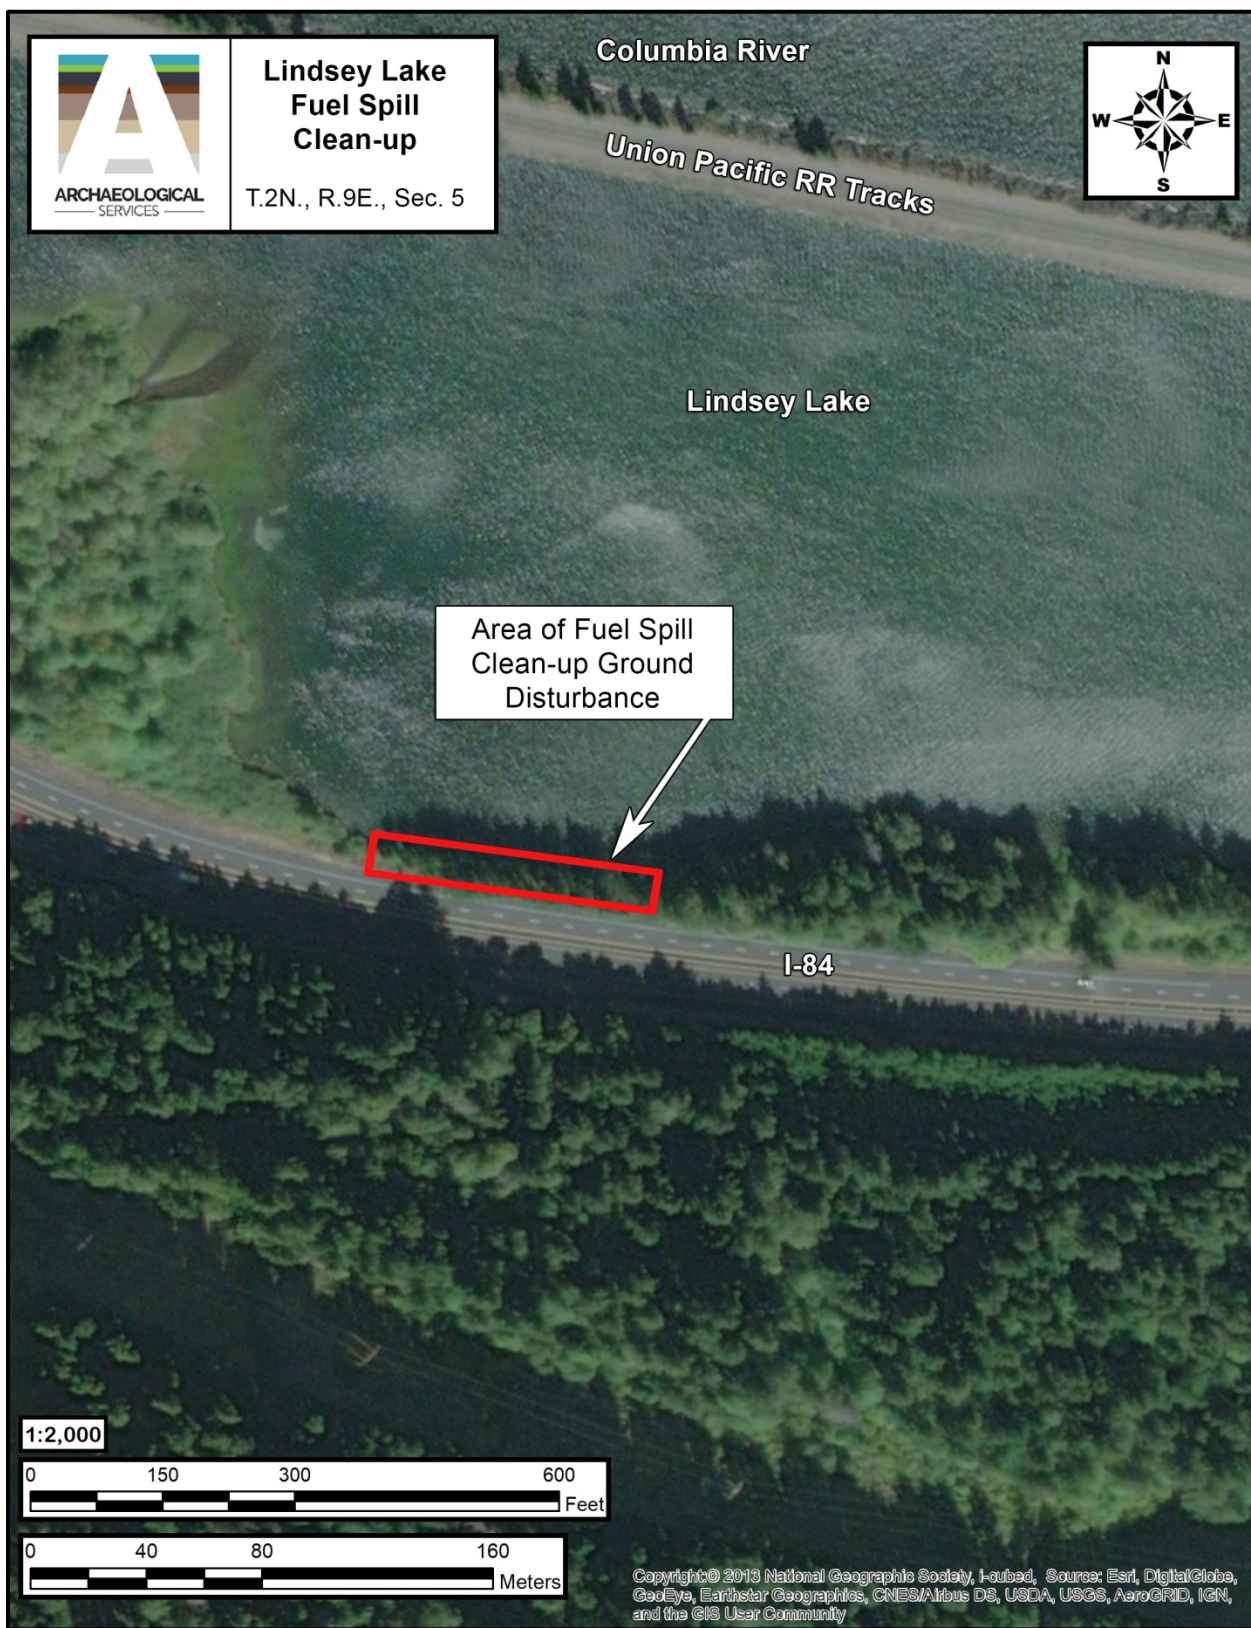
The day's ground disturbing work consisted of hand-excavating a shallow trench along the north-facing slope between the north edge of I-84 and the south shore of Lindsey Lake (Figures 2 & 3). Due to the high levels of volatile organic compounds (VOCs) in the air when the digging was taking place, ASCC was limited to observing the hand excavation from the edge of the pavement about 10 meters from the trench (Figure 4). However, the archaeologist was able to observe the sediments from that distance and take zoomed-in photos of the trench, which was only excavated approximately 1-1.5 feet (30-45cm) below existing grade. Several modern bottles and cans were observed as well as an unidentifiable piece of cast iron (Figure 5). The trench was completed around 4:30 p.m. It was apparent that the ground disturbance had taken place within fill material used to create the I-84 road prism.

Figure 2. Aerial photomap overlaid with the area of ground disturbance monitored by ASCC.

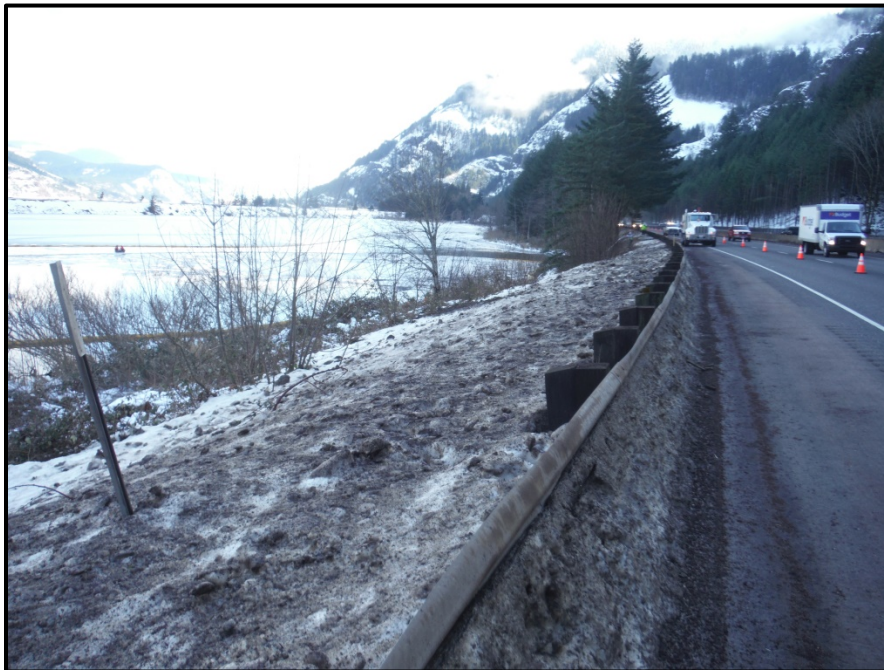
Figure 3. East facing photo of the snow-covered embankment prior to any ground disturbance (2/18/19).

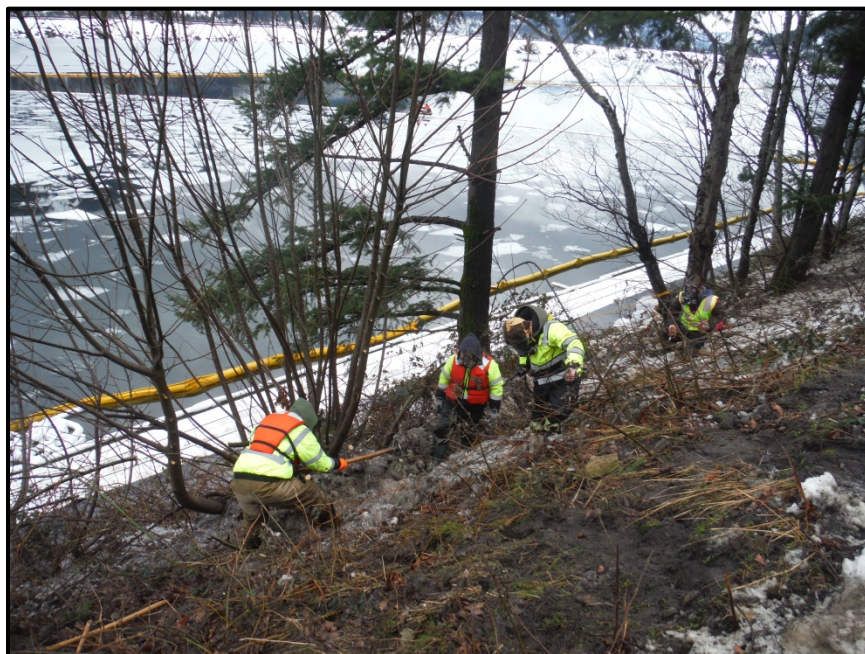
Figure 4. Northeast facing photo of the crew excavating a shallow trench (2/18/19).

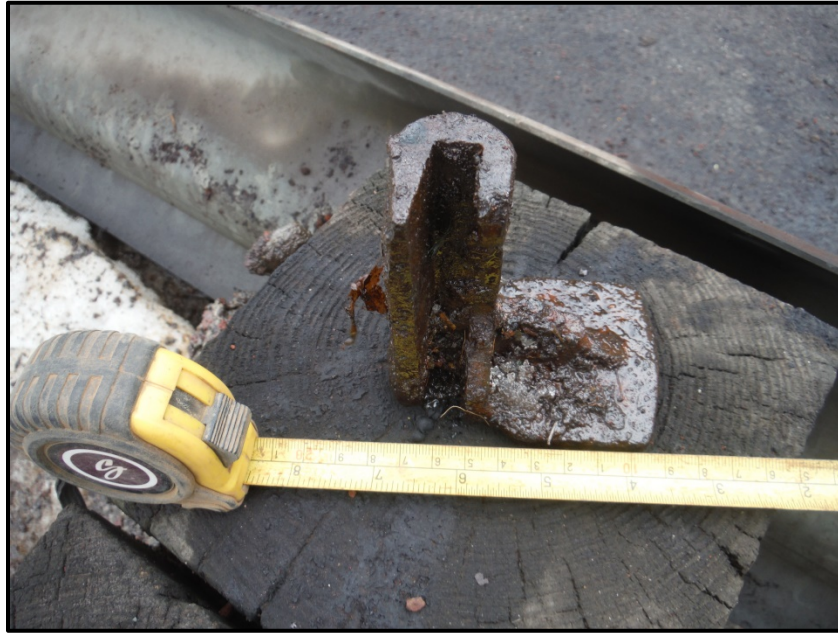
Figure 5. Photo of cast iron item found while monitoring on 2/18/19.

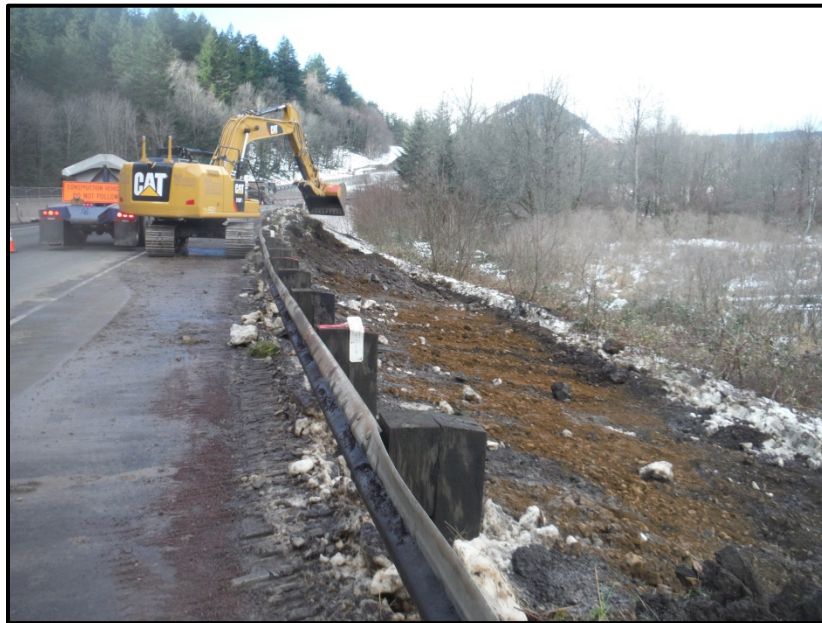
February 20th: ASCC Senior Archaeologist and Principal Investigator, Alexander Gall, M.A., RPA received a phone call from Mr. Honsberger that additional excavation of contaminated snow and sediments along the north-facing slope had been approved. Mr. Gall arrived on-site at 12:30 p.m. and checked in with project personnel. The ground disturbance consisted of using a track-mount CAT 316F excavator equipped with a 48-inch wide flat bucket to scrape the contaminated snow and upper sediments from the same slope that had the trench excavated into it on Monday, February 18 (Figure 6). The materials were then loaded onto dump trucks and trucked to a disposal site. ASCC observed this activity until the cessation of the work for the day. Modern roadside debris was noted. It was apparent that the ground disturbance had taken place within fill material used to create the I-84 road prism.

Figure 6. West facing photo of the contaminated snow and sediment removal on 2/20/19.

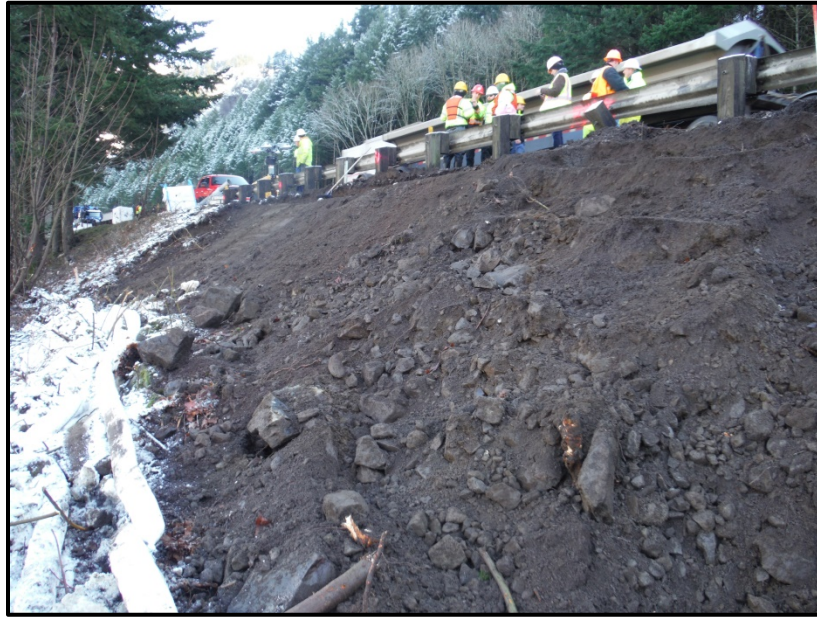
inspect the area that had been affected by the day's soil scraping (Figure 7). Work was completed at 2:45 p.m. No cultural material was observed and the sediments still appeared consistent with road prism fill.

Figure 7. Southwest facing photo of the scraped embankment on 2/21/19.

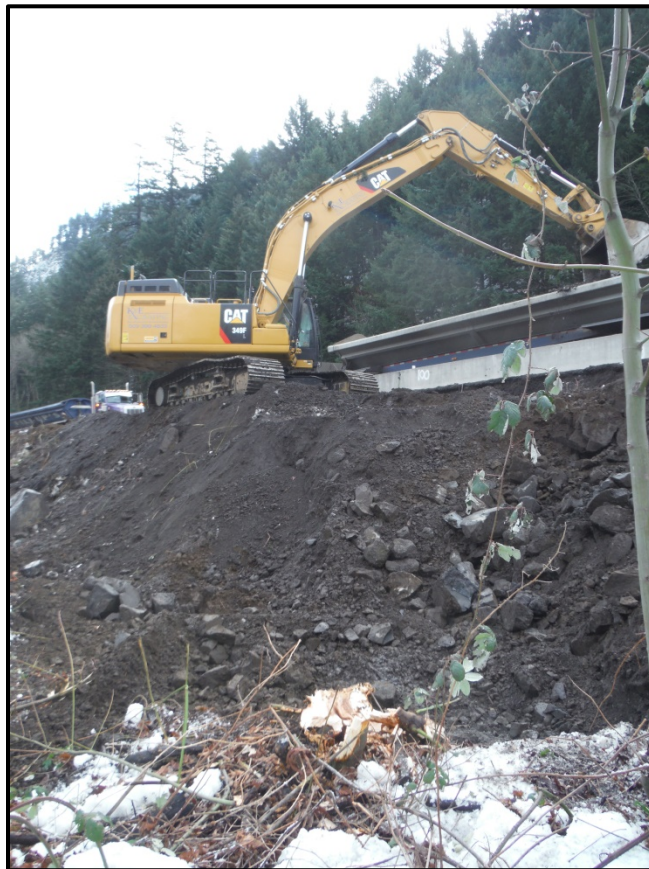
February 22: ASCC Archaeologist Michael Smith, B.A. arrived at 7:30 a.m. and participated in the morning safety meeting. A larger excavator, a CAT 349F with a 48-inch flat bucket, had arrived on-site to access soils further down the embankment (Figure 8). Monitoring of the soil removal continued to the end of the day at 3:30 p.m. The only item of interest noted during the day of monitoring was a metal clasp/hook approximately 8.5 inches in length (Figure 9).

Figure 8. Southeast facing photo of the excavator loading a dump truck on 2/22/19.

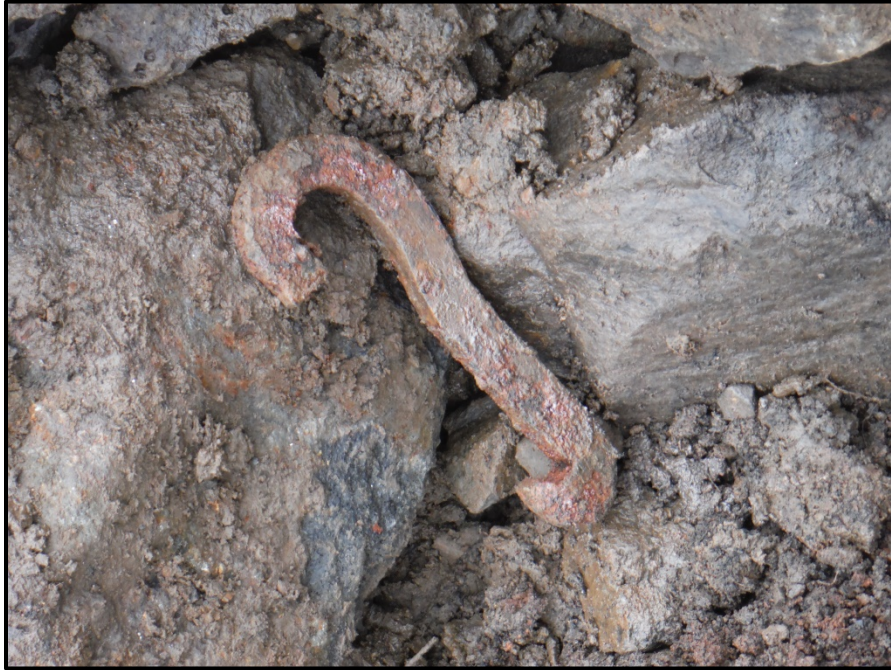
Figure 9. Photo of the metal clasp/hook found on 2/22/19.
